MULTI POOL PROJECT

Pool Conditions Assessment

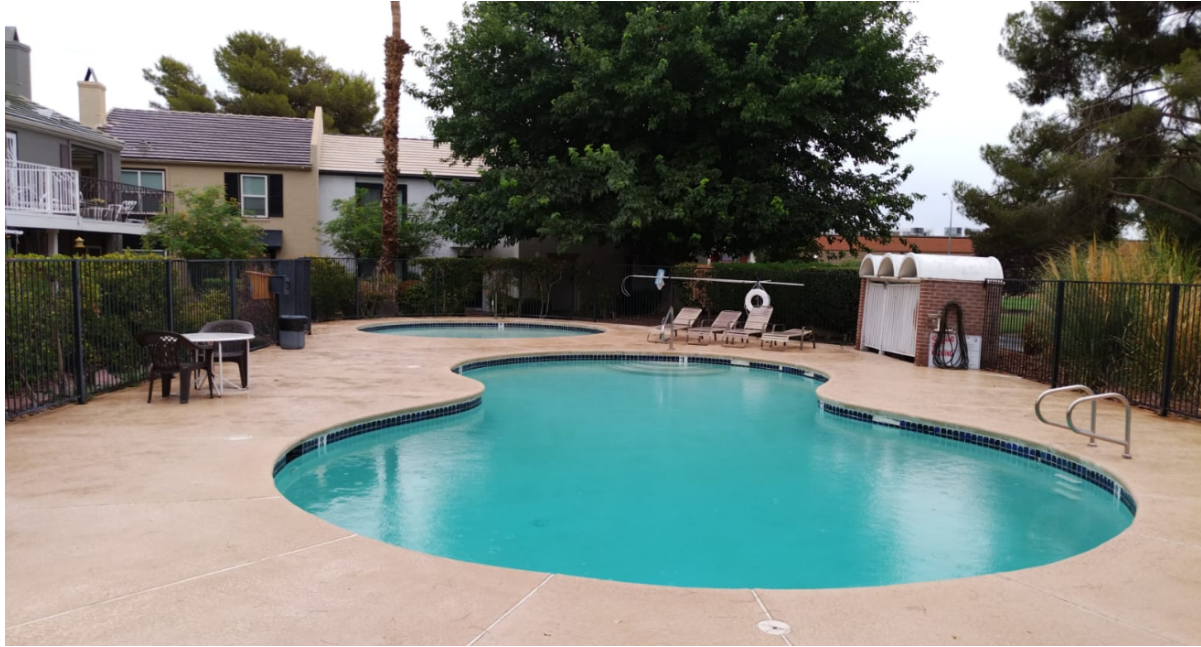
Pool 1:

- Southern Nevada Health District identified some missing tiles that must be replaced. Also noted etching in the plaster finish in some areas.
- The issues appear relatively minor currently, but should be monitored and addressed to prevent more severe deterioration over time.

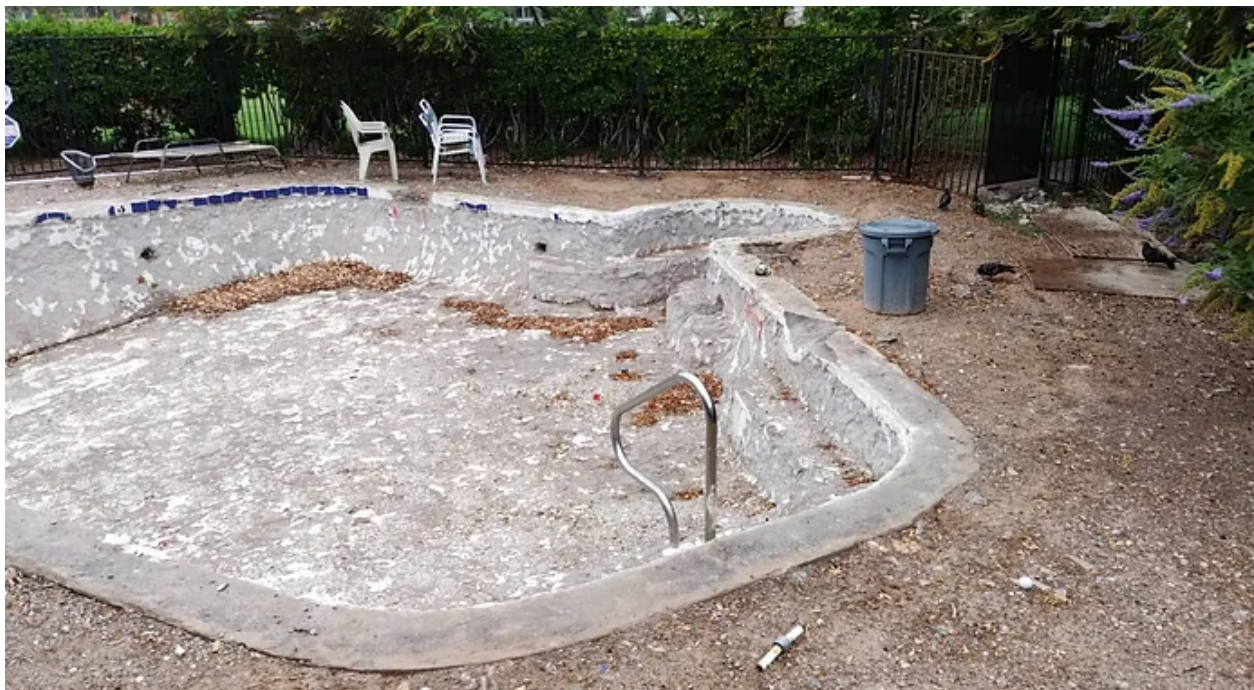
Pool 3:

Pool 3 has significant structural issues, with a large void detected underneath the pool during recent demolition work. This void was likely caused over time by water leaking and eroding the soil underneath, which contains gypsum that can dissolve easily. The void requires major subgrade remediation including densification and soil stabilization. Without proper structural repairs, Pool 3 could be at risk of collapse.

- Closed indefinitely due to major void detected underneath pool during demolition work.
- Geotechnical report recommended subgrade densification and soil recompaction to stabilize structure.
- High probability of collapse without proper structural repairs.
- Two bid options obtained: \$19,200- \$78,000 to fill in and demolish pool completely, or higher cost to fully repair and reopen pool.

- Fill in completely at an estimated cost of \$19,200 - \$78,000, rather than attempting expensive subgrade structural repairs. Removes a collapsed safety hazard.

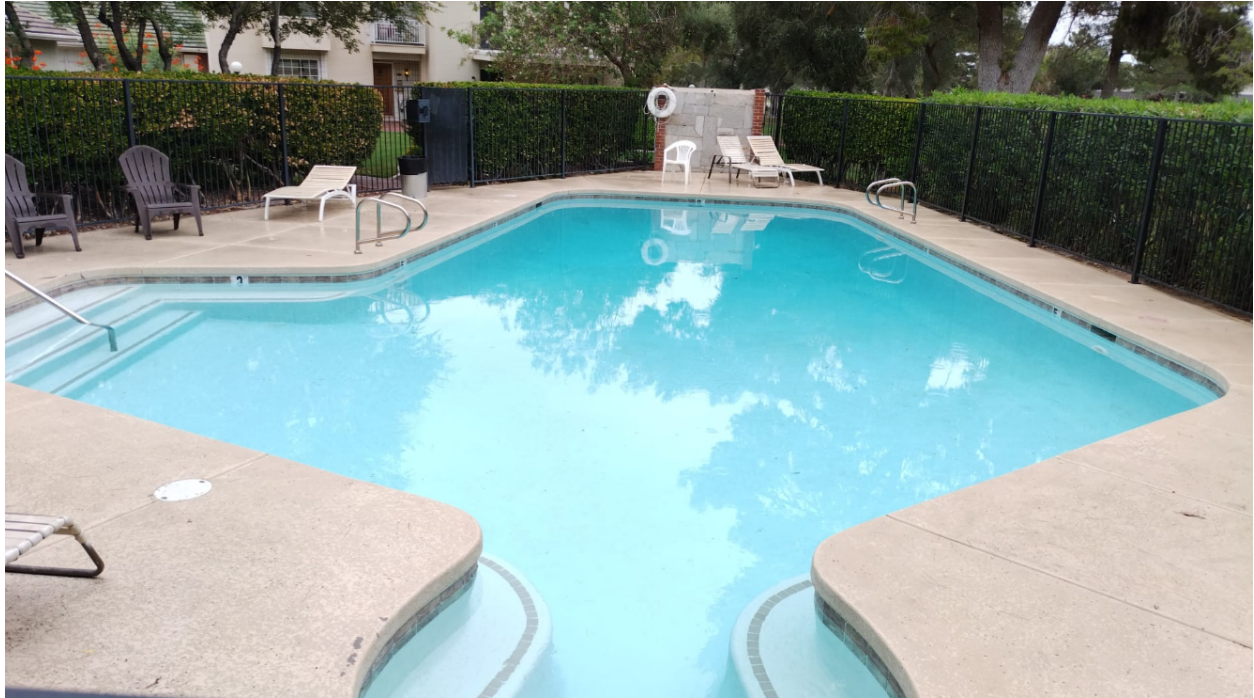
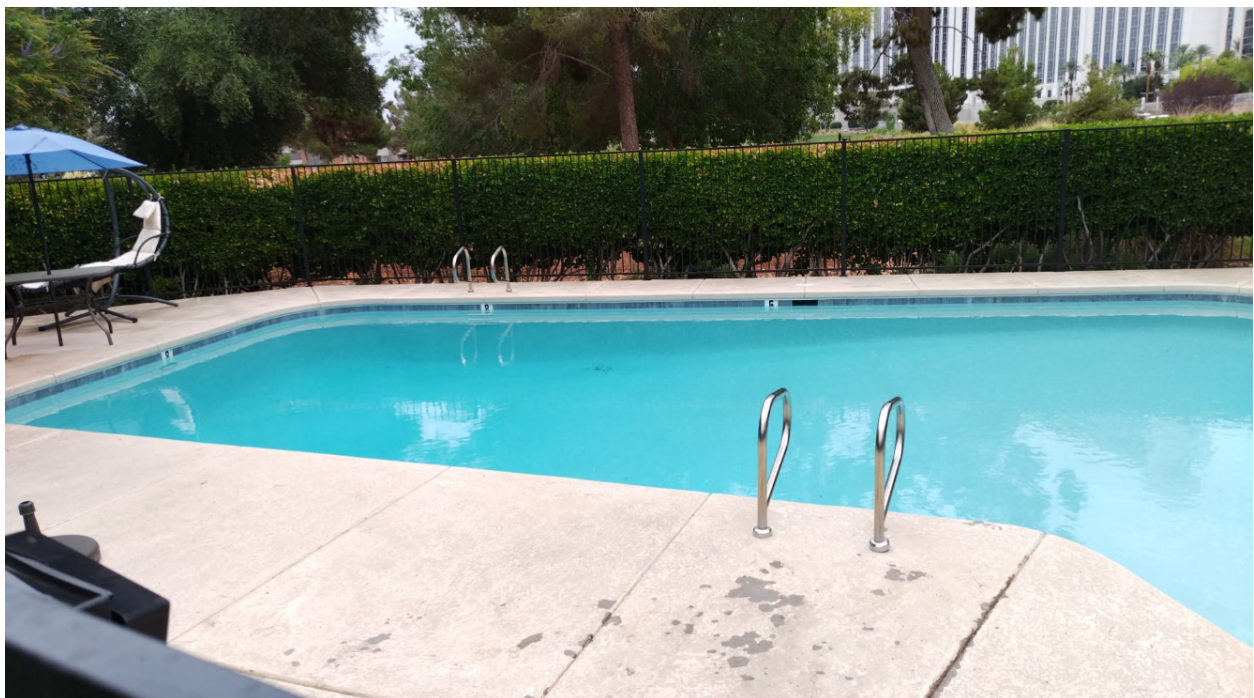
Pools 9 and 10:

- SNHD noted some plaster etching and minor tile damage.
- Deck coating beginning to peel on Pool 10.
- Equipment recently updated on both pools.
- Limited repairs needed in short term.
